City of Evans

URBAN RENEWAL AREA CONDITIONS SURVEY

Prepared
On November 6, 2009
Scheduled for Approval
Tuesday, November 17, 2009

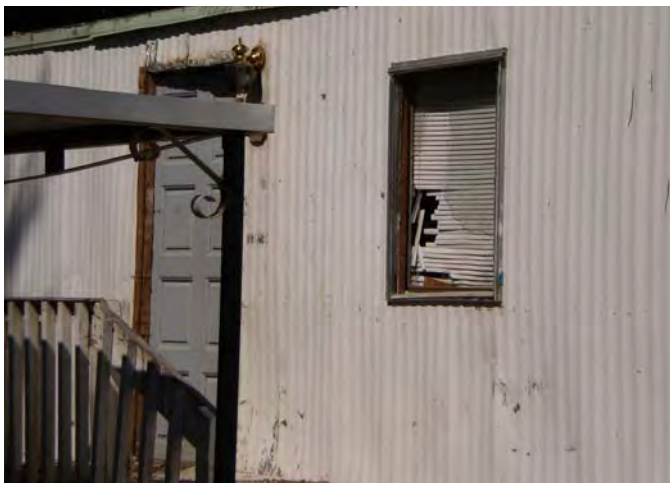
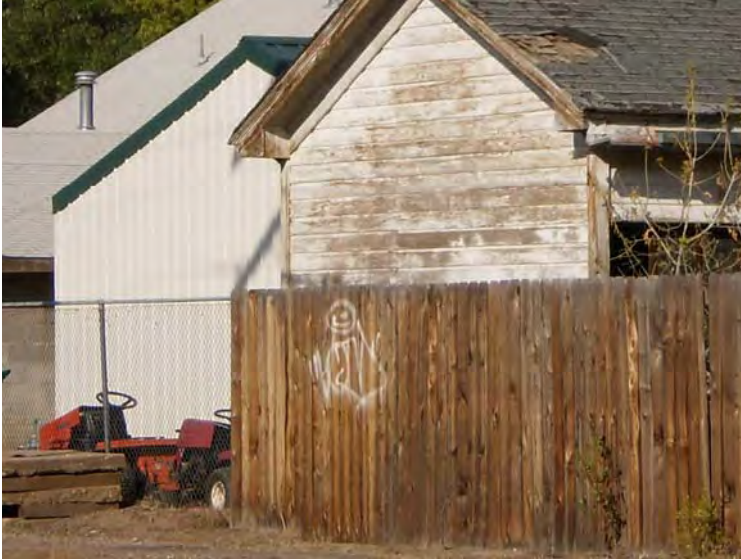
Slum, Deteriorated and Deteriorating Structures

This section summarizes the on-site investigations of deterioration within the Study Area. The condition of deteriorating or deteriorated structures was primarily established through field survey work and observation of exterior physical conditions within the Study Area. No interior inspections were conducted. The most common examples of

structural deterioration found in the Study Area involved poorly maintained exterior finishes, and fascia and roof deterioration. Many properties were observed to have outbuildings in disrepair. Some older properties were also found to have window, roof, and wall deterioration. Other Study Area structural problems include deterioration of exterior walls, gutters, and fences.

Examples of properties affected by Condition (a) are shown in the photos above and attached as Exhibit H.

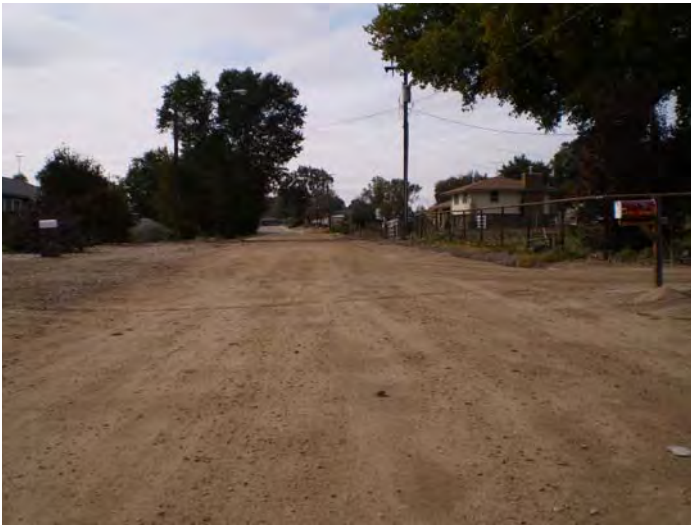
Defective or Inadequate Street Layout

Conditions typically associated with faulty street layout include poor vehicular access and/or internal circulation; substandard driveway definition and parking layout (e.g. lack of curb cuts, awkward entrance and exit points); offset or irregular intersections; substandard or nonexistent pedestrian circulation.

The photograph above and the photographs in Exhibit H depict unpaved streets, substandard vehicular access, and dead-end streets.

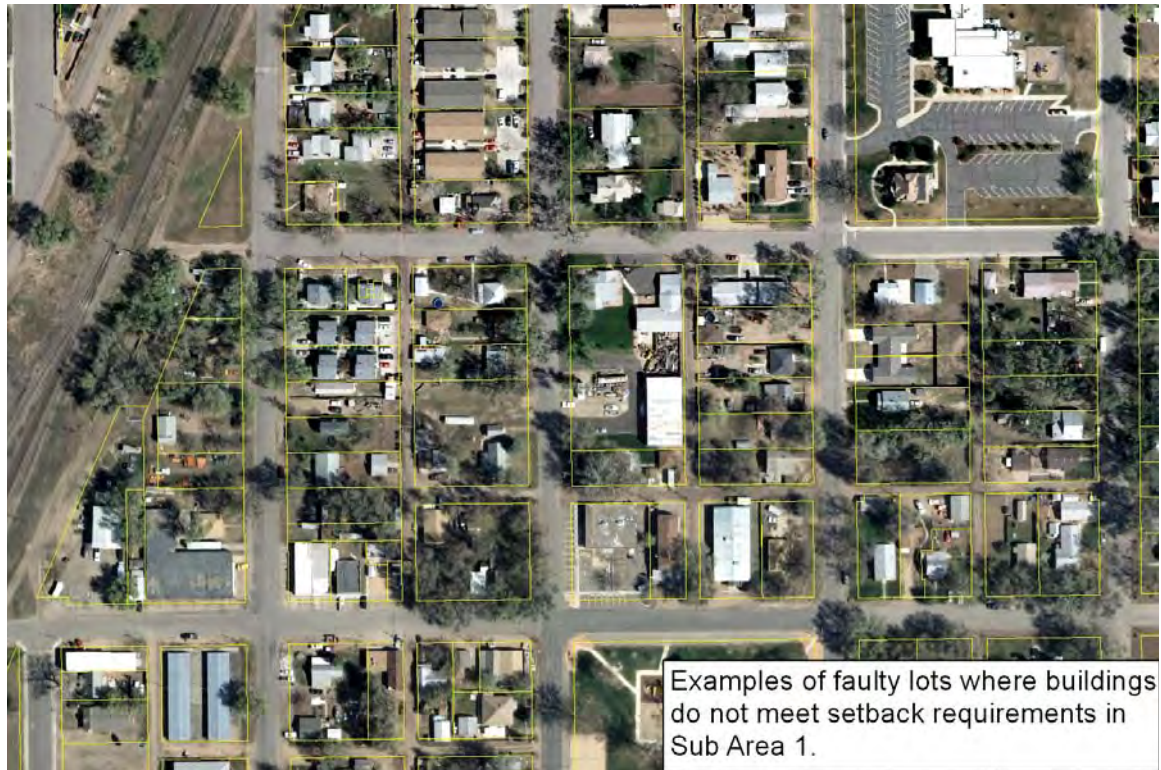
layout and size, as well as conformity of use. Lot layout is deemed to be faulty if the configuration relative to the street is contrary to what is desired for development. Lot shape is considered faulty if the shape is unusual to an extent that it deters or constraints development options. Poor access, a condition related to poor lot layout, is discussed in the subsection above under *Defective or Inadequate Street Layout*, and is also indicative of faulty lot layout.

Many lots in the Study Area are deep and narrow. Some lots on Pleasant Acres Drive are as much as four times as deep as they are wide. In other areas, lots are triangular due to the presence of the railroad or highway. Redevelopment on these lots is constrained because the existing buildings do not meet setback requirements.

The aerial photograph presented above illustrates several examples of faulty lots in the Study Area, as per the statute Condition (c).

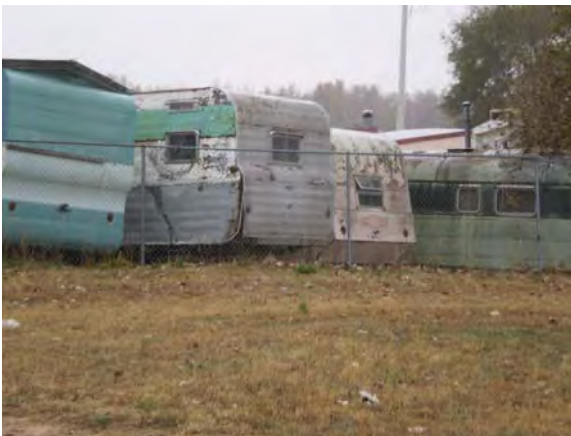
Unsanitary or Unsafe Conditions

Poorly lit areas are prevalent throughout the Study Area particularly in large vacant parcels, parking lots in front of or behind older businesses, and industrial parcels in general. Problems of code violations can be found throughout the Study Area as well, most commonly in older multifamily residential areas.

Examples of statute condition (d) are presented in the photo above and in Exhibit H.

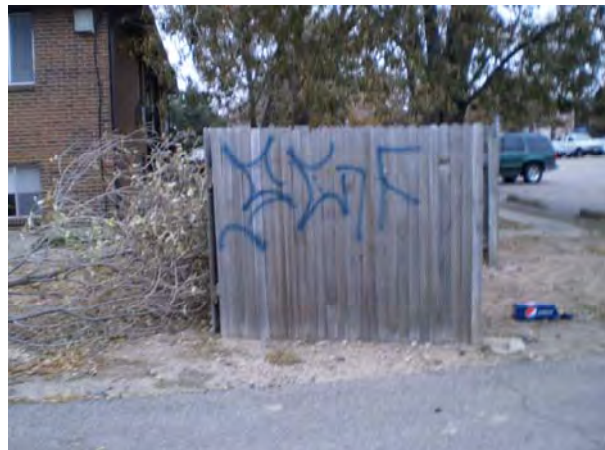
Deterioration of Site and Other Improvements

A variety of blight conditions were observed within the Study Area related to the deterioration of site and other improvements. These conditions most commonly include incompatible mixtures of residential and industrial uses on adjacent lots; unproductive and vacant land; nonconforming buildings and uses; parking surface deterioration and unscreened trash

and mechanical equipment. Several sites were found to have site maintenance problems, a lack of landscaping, or signage problems. Examples of condition (e) are found throughout the Study Area, as shown in the photograph above and in Exhibit H.

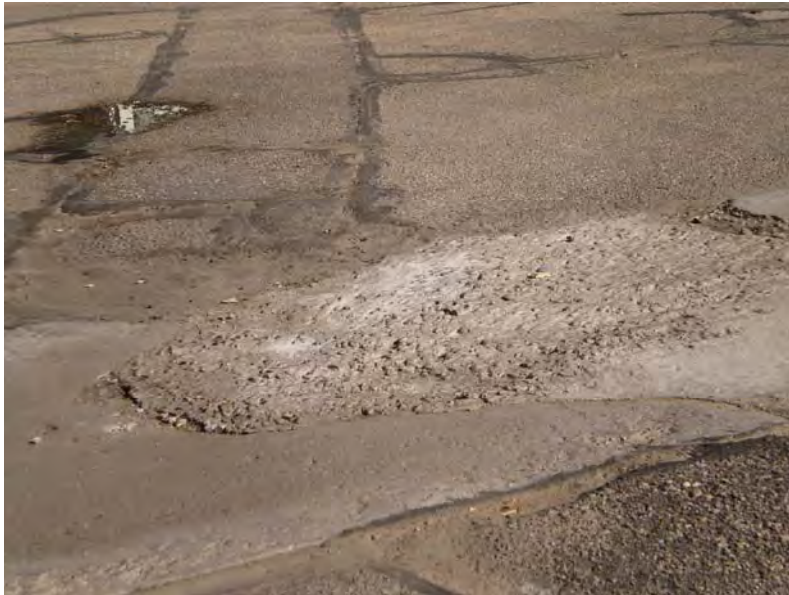
Unusual topography or Inadequate Public Improvements or Utilities

Areas with inadequate public improvements or utilities include those with street pavement deterioration and lack of paved streets, gaps or deterioration in

sidewalks, and lack of landscaping, all of which can be found in the Study Area. Additionally, areas east of Highway 85 are irrigated by a deteriorating flood irrigation system. Finally, almost all parcels are considered, for purposes of this analysis, to have outdated power and phone system provision because of the reliance on

Examples of condition (f) are shown in the photo above and in Exhibit H.

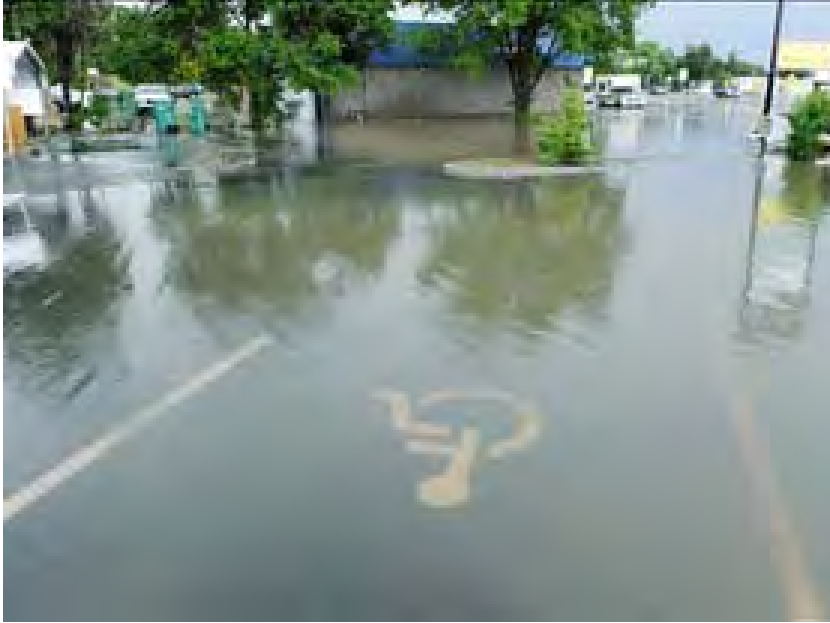
Existence of Conditions that Endanger Life or Property by Fire or Other Causes

In addition to hazards due to flooding mentioned previously under condition (d), numerous hazards exist in the Study Area due to dead trees and inadequate separation of structures and substandard electrical connections for mobile homes.

Examples of condition (h) are shown above and in Exhibit H. Above photo by Eric Bellamy, copyright 2009 The Greeley Tribune
